# Printed Circuit Board Reliability and Integrity Characterization Using MAJIC

M. Simard-Normandin  
MuAnalysis Inc.  
Ottawa, ON, Canada

## Abstract

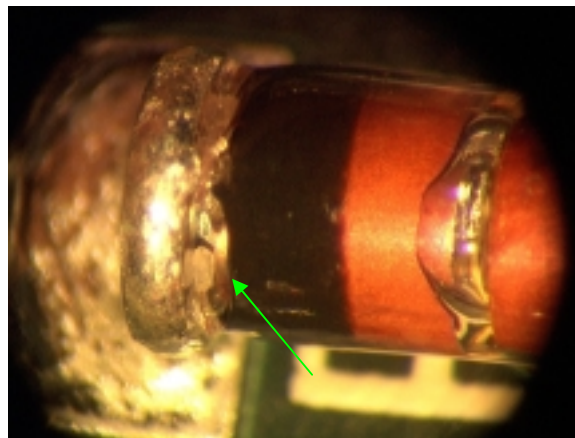
The IPC-A-610D is very precise regarding how visual inspection should be performed. In lead-free soldering we have often found that some components cannot handle the extra heat. An example of a cracked diode is shown in Figure 1.

**Figure 1 - A cracked diode.**

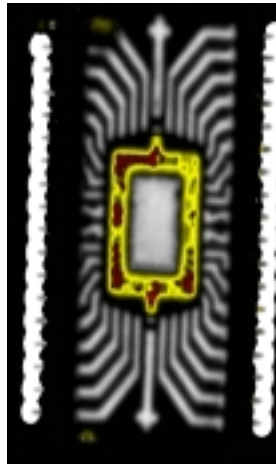
The extra thermal budget of lead free soldering is known to reduce the Moisture Sensitivity Level of plastic encapsulated ICs. Acoustic microscopy reveals if any delamination has occurred during the soldering process. ICs showing delamination can still test good electrically if the extent of the delamination is not severe and the wire bonds are still intact. However delamination is a latent defect that will reduce the long term reliability of the product. Eventually ionic contamination will cause bond pad corrosion or leakage. Evaluation boards often use dummy components without die and cannot detect such issues.

**Figure 2 – An IC showing delamination of the lead- frame, revealed by Acoustic microscopy. This IC tested good electrically.**

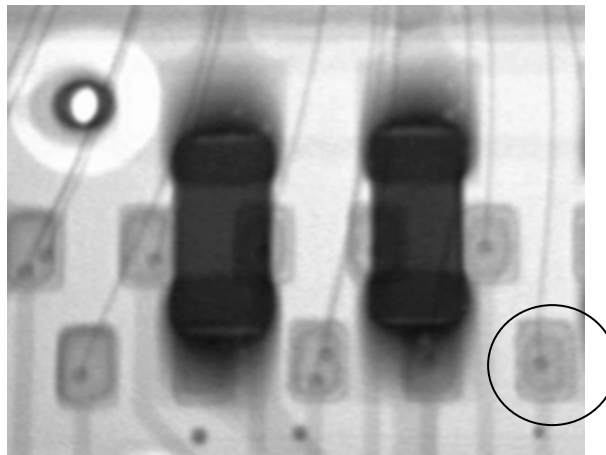
XRAY inspection is common in the industry to look at solder joints, particularly in BGAs and QFNs where the joint is hidden from sight. However it is time consuming and one must use high resolution to capture subtle wetting issues such as the ones shown in Figure3.

**Figure 3 – Poor wetting and incomplete coverage of most of the solder pads in a QFN device. Only a small section of the device is shown. The worst pad is circled. The two discrete components in the field of view are on the other side of the board.**

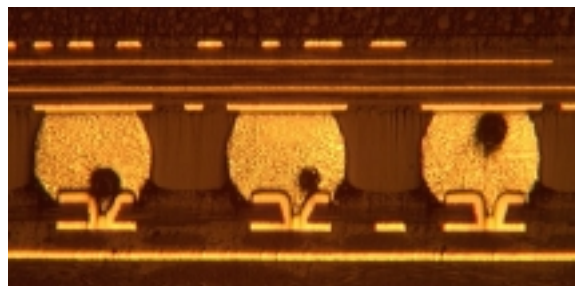
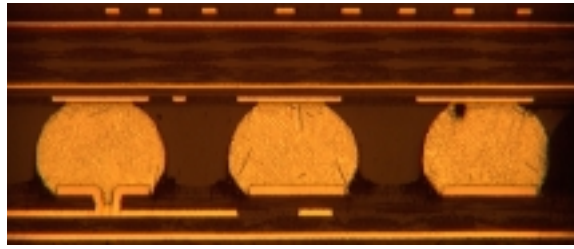
After the stresses are applied, devices of each type are cross-sectioned and inspected with high resolution optical and electron microscopy. BGA balls are notorious for voids, which can usually be detected by XRAY. Different components can behave differently on the same board as shown in Figure 4, and cross-section analysis adds insight into the product quality assessment.

**Figure 4 – BGA balls from two different components on the same product, showing significantly different voiding behavior.**

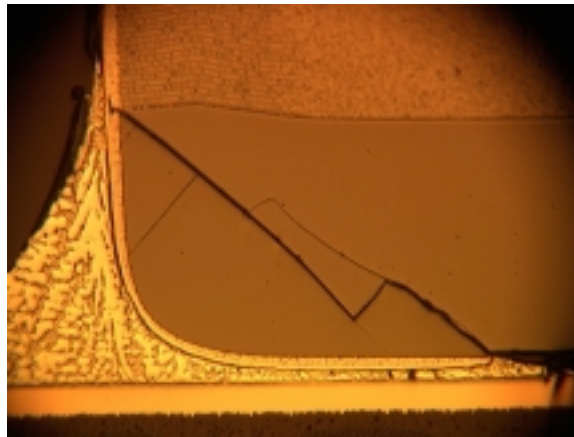
Cracked capacitors are very difficult to detect at the board level. Although we have found that the capacitor of Figure 5 had cracked we could not detect the crack with acoustic microscopy. The geometry of the plates caused attenuation that hid the acoustic signal. Electrically this capacitor was still good since the crack had not reached the plates. Optically the crack could not be detected since it is within the solder fillet and hidden from view. This capacitor would eventually fail electrically, damaging the product. It is not clear whether this capacitor failed because of heat or because of the mechanical stresses, but understanding that there is a reliability risk associated with this component, it is easy to devise experiments to figure out the root cause and address the issue.

**Figure 5 – Capacitor with crack that is invisible to optical inspection and acoustic microscopy.**

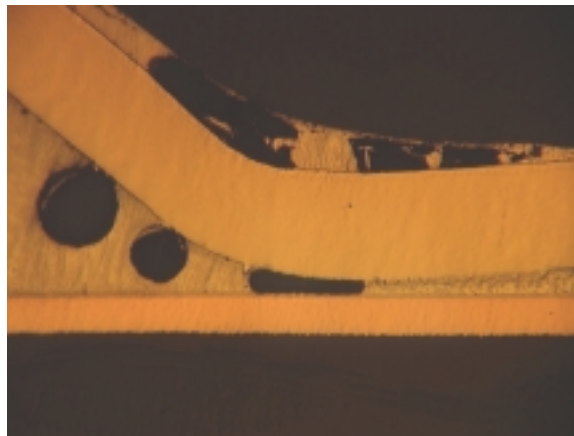
Wetting problems should be detectable at visual inspection, but there are situations that elude detection. An example is shown in Figure 6: a gull wing component that looked good at visual inspection proved to be of poor quality after cross-section. It is likely that this solder joint will fail prematurely in the life of the product.

**Figure 6 – Solder joint on gull wing component showing poor wetting, undetectable at visual inspection.**

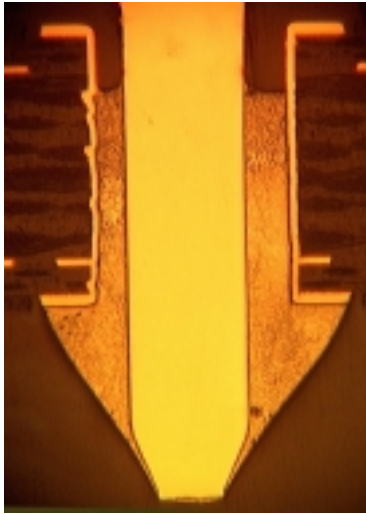
Plated through holes are very difficult to inspect. IPC-A-610D determines that the holes should be at least 75% filled. The pin of Figure 7 is very close to this figure of merit but, because of its location, the void could not be seen optically. In Figure 8, the pin passed visual inspection, but is it filled? Both these devices are likely to fail prematurely.

**Figure 7- Pin in plated through via showing border line fill, not detectable by visual inspection because of location.**

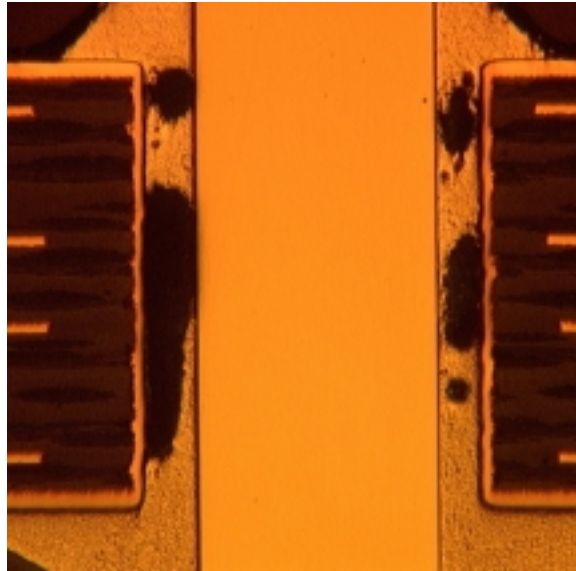
**Figure 8 – Does this pin pass? It passed visual inspection.**

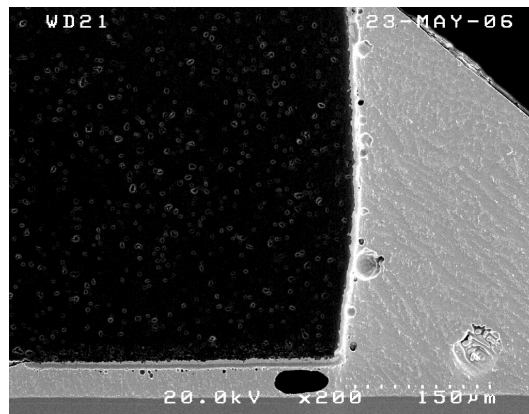
There is more to manufacturing quality than solder joint integrity. How does one assess component cleanliness and handling? In the examples of Figures 9 and 10 we have observed voids and bubbles in the solder on the component side and all along a pin. Both these incidences occurred on the same board and the other components sectioned did not show anything abnormal. We suspect that the resistor and connector in question were contaminated. Perhaps they had been handled improperly or were received in a contaminated state.

**Figure 9 – Voids and bubbles on the component side of the solder joint of a resistor. It is possible that the component was contaminated.**

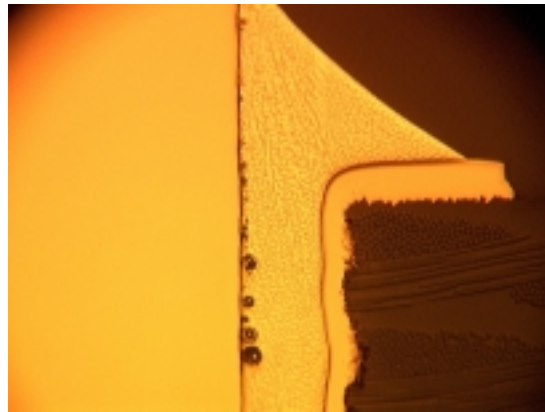
**Figure 10 – Voids and bubbles in the solder joint along the pin of a connector. It is possible that the component was contaminated.**

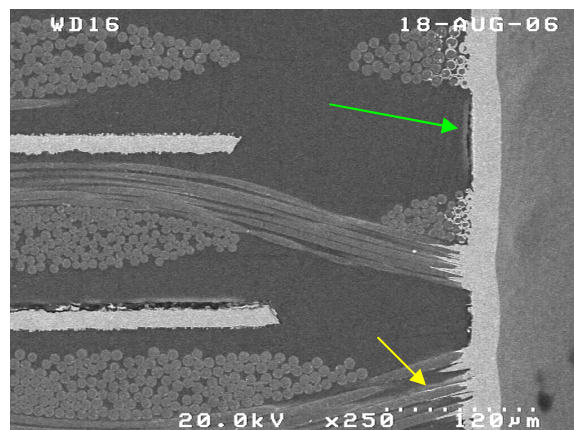
A significant area of concern and a frequently observed cause of failures in electronic products is the integrity of the printed circuit board itself. The best assembly process cannot compensate for board defects causing shorts, intermittents or opens. Electrical problems related to poor board construction do not occur immediately and are not necessarily detected at electrical testing. The latent defects will eventually become evident and cause failures for which the assembly manufacturer is likely to be blamed. The MAJIC stresses imposed on the product are not severe and should not cause cracking or delamination of a good board. However, if the board is improperly constructed, the stresses are likely to expose the flaws, particularly at cross-section where tiny defects can be seen by electron microscopy. Separation of the via barrel from the laminate, such as shown in Figure 11, is unfortunately very common and often leads to more severe damage including open circuits.

**Figure 11- Cross-section of board showing separation between the laminate and the copper traces and the laminate and the copper barrel (green arrows). This board also exhibits significant copper wicking along the barrel of the via (yellow arrows).**

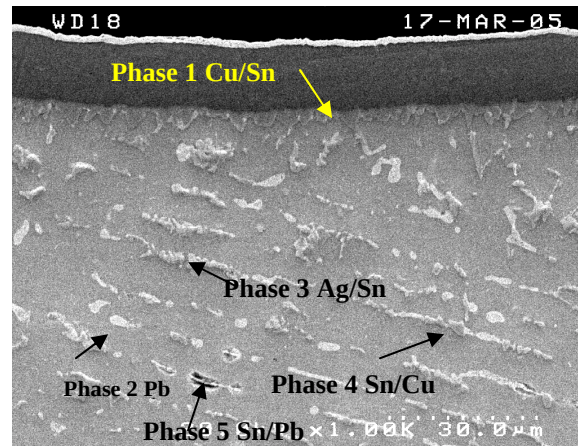
The last part of the MAJIC methodology is to examine the various compound/intermetallic phases created during the soldering process to ensure that proper reflow has occurred. Surprises, such as the unwanted presence of lead, may appear.

**Figure 12 – EDX analysis shows the various compound/intermetallic phases present in this BGA ball cross-section.**
