# Aftermarket LED-based electronic devices, buyer beware

M. Simard-Normandin, C. Banks, S. Trifoli  
MuAnalysis  
Ottawa, Ontario, Canada  
martine@muanalysis.com

This paper presents a case study involving replacement H4 light bulbs with LED devices purchased from eBay. The product packaging makes several claims, several of which are not met. In particular, the LEDs used are not those indicated on the package. There are significant differences in construction between the LEDs used in the product and genuine LEDs purchased separately from authorized distributors.

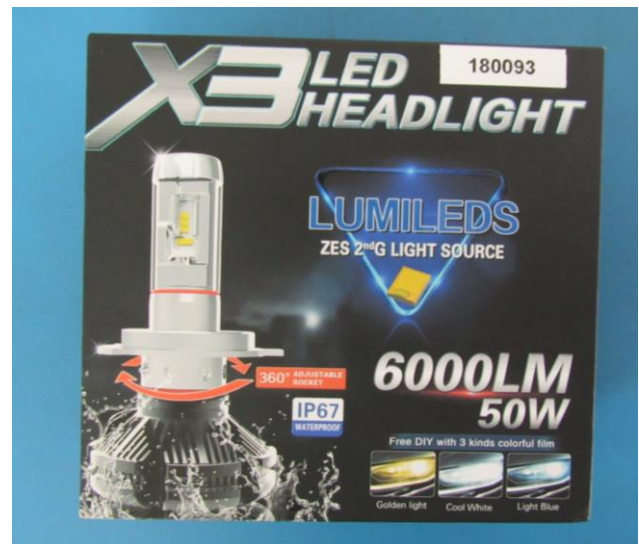
Figure 2. Product received. The packaging is different but all the claims are identical.

The product chosen for this project is a LED-based replacement H4 headlight. It was readily available, reasonably priced and claimed to contain Luxeon ZES LEDs. There is even a photo of the LED emitter on the package which matches publicity images from Lumileds. The description of the ordered product is shown in Figure 1 and the product received is shown in Figure 2.

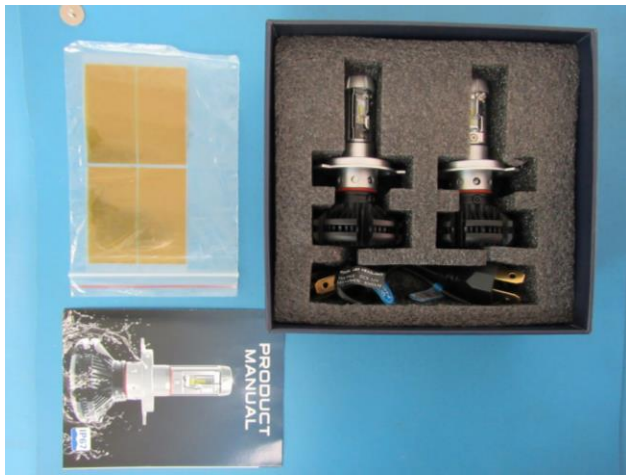
Inside the box were two light fixtures, an instruction manual and a bag containing colored plastic films. See Figure 3.

**Figure 3.** The contents of the box.

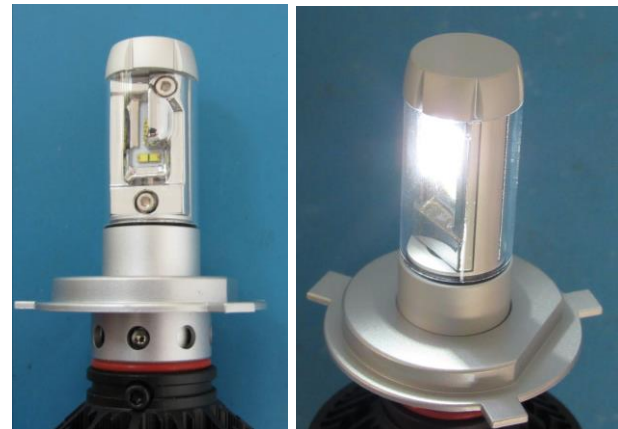
The first step is to try to light it. Since this is intended for automotive use and is rated DC 9-32 V, this is simple.

**Figure 6.** Light bulb off and lit.

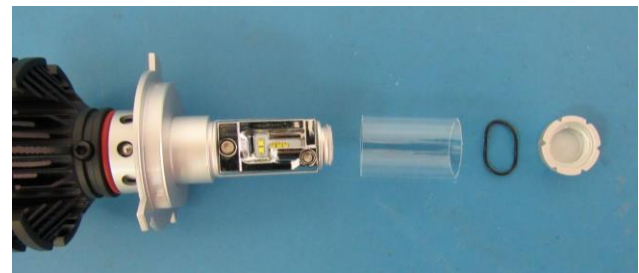
Deconstruction was also found to be simple. The top cap can be unscrewed, revealing a plastic tube around the LEDs which is meant to accommodate the colored films.

**Figure 7.** Partially deconstructed light bulb.

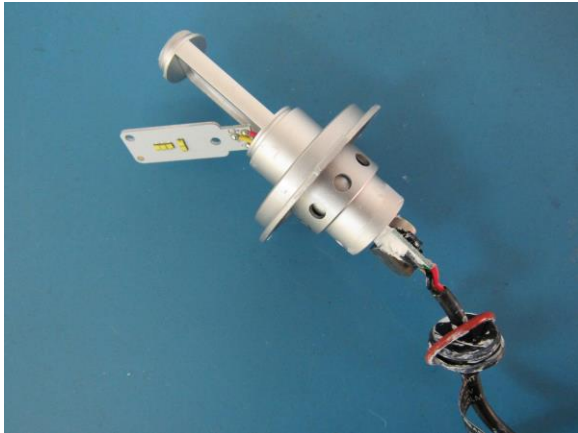
With further deconstruction, the reflector was removed and the driving circuitry pulled out of the neck.

**Figure 8.** Further deconstructed light bulb showing one LED panel. There are two LED panels, one on each side of the bulb.
